NEW LIFE FOR AN OLD PORCH

In the Third Lake Ridge Historic District in Madison, Wisc., front porches are a prominent architectural feature of many of the homes, which were built between the 1850s and the 1920s. This particular Victorian-style home dates to 1899, and the porch (like many in this neighborhood) suffered from shallow footings, rotten floor boards, and roof leaks. My employer, TDS Custom Construction, a 30+ year-old design/build firm located a few blocks away from the district, was hired to restore the porch as well as design and build a single-car garage for the property that would stylistically complement the original house.

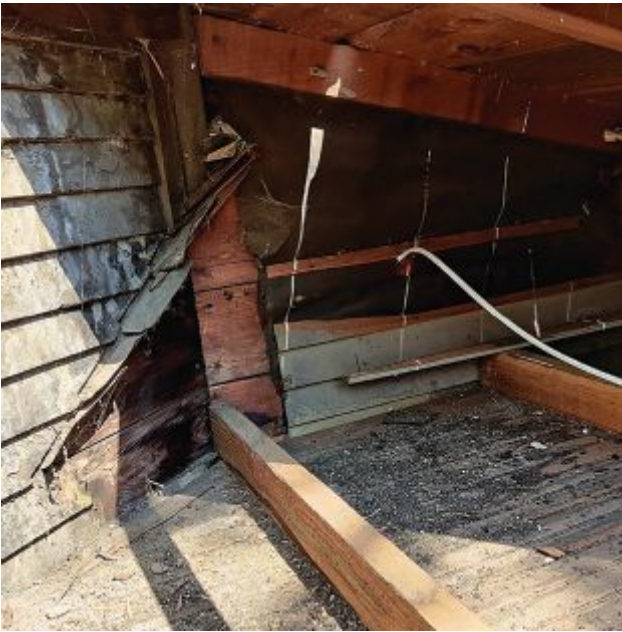
We started by temporarily posting under each corner of the sagging roof using screw jacks to try and level it **(A)**. The porch was nearly 2 inches out of level from left to right, and one of our biggest concerns was the connection to the house as we began to jack the corner up to level the roof line. To help with any stress or settling that might occur because of this, we built a temporary shoring wall under the roof right against the house. Next, we removed a few sections of skip sheathing near the peak of the porch roof to see how it was fastened to the house and discovered that the roof rafters and ceiling joists were only toenailed to the existing siding with 10d nails (the porch wasn't original to the house). As the porch framing settled, the rafters had pulled away from the house **(B)**.
